Test Report

Report No. : SUER241000112071 **Release date**.....: 2024-11-19

Product Description..... : HYGIENIC DESIGN STAINLESS STEEL CABLE GLAND

Product Model No : CG-M20

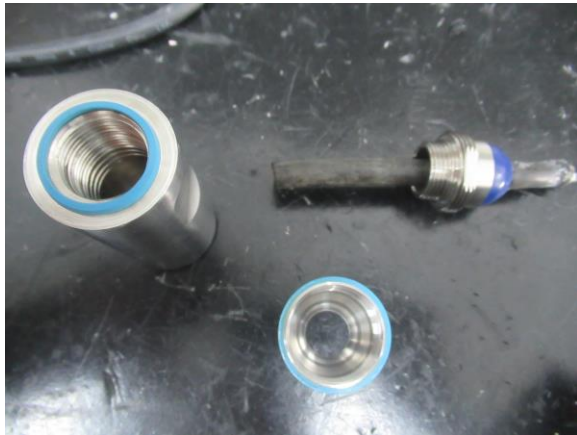
After test-Disassembly inspection

Sample Number	Test Result
SUER2410001120CO M1	After test, there was no visible dust ingress.

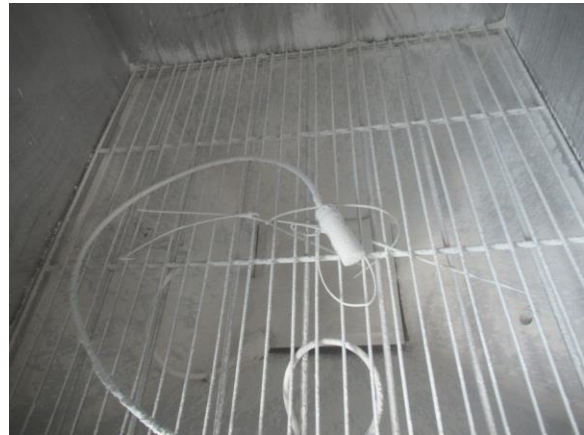
During test
